**Demonstration and Evaluation of Technologies for
Determining the Suitability of USTs
for Upgrading with Cathodic Protection**

**Jarius D. Flora, Jr.
Midwest Research Institute
Kansas City, Missouri 64110**

**National Risk Management Research Laboratory
Office of Research and Development
U.S. Environmental Protection Agency
Cincinnati, Ohio 45268**

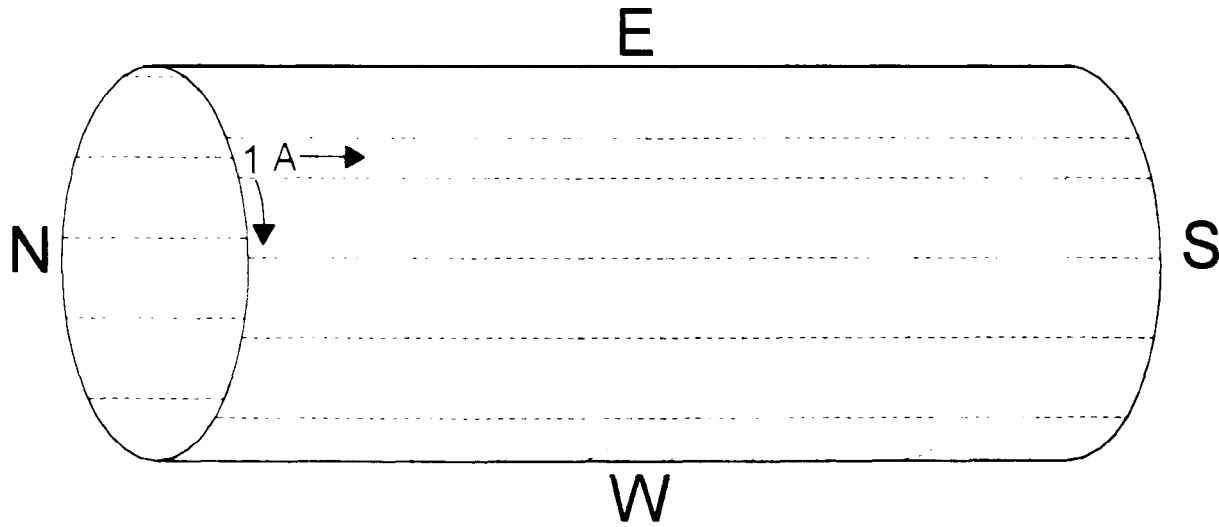
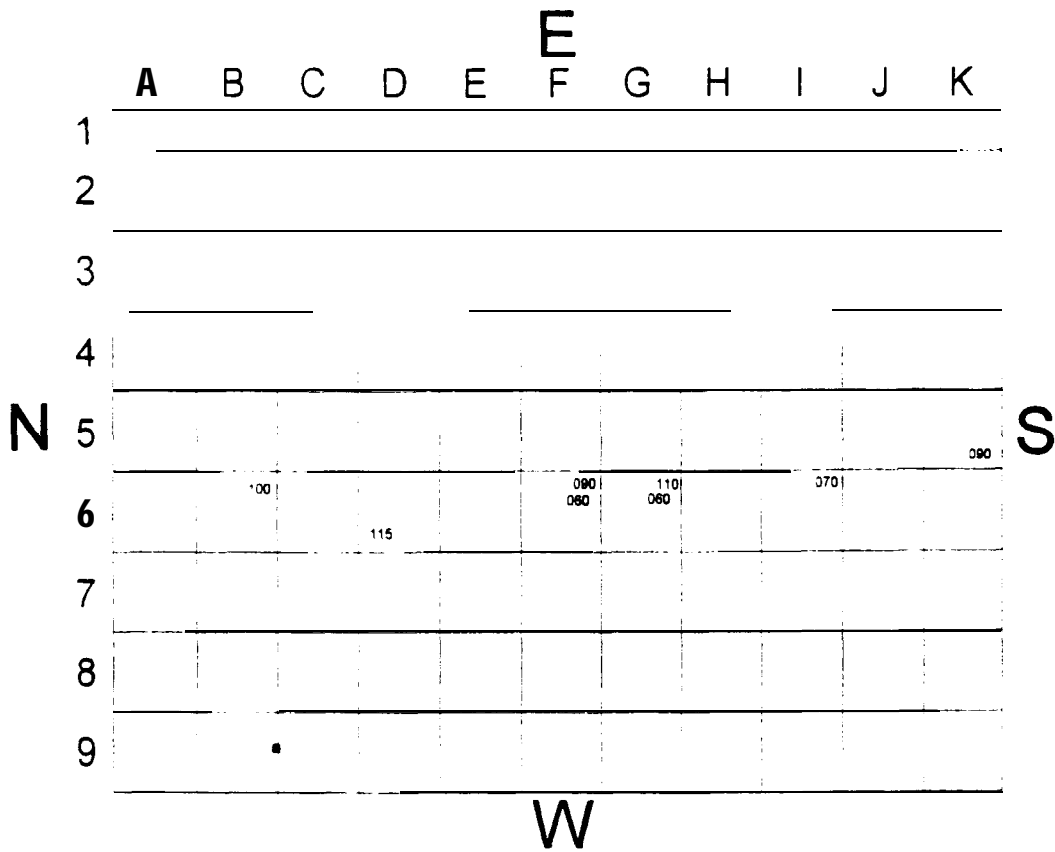
Tank #18

Immediately after removal, adhering clay soil was scraped from the sides of the tank. The tank was visually inspected and a perforation found about midway down the east side of the tank a few feet from its north end. A probe placed into the hole confirmed that it completely penetrated the wall (Figure 3). Selected areas around the perforation were abrasively blasted to bare metal and a number of obvious external pits were observed. Ultrasonic measurements were made on one end cap and a sidewall to obtain wall thickness data. These thickness measurements averaged 0.250 inch at section G-1 and 0.279 at the end cap.

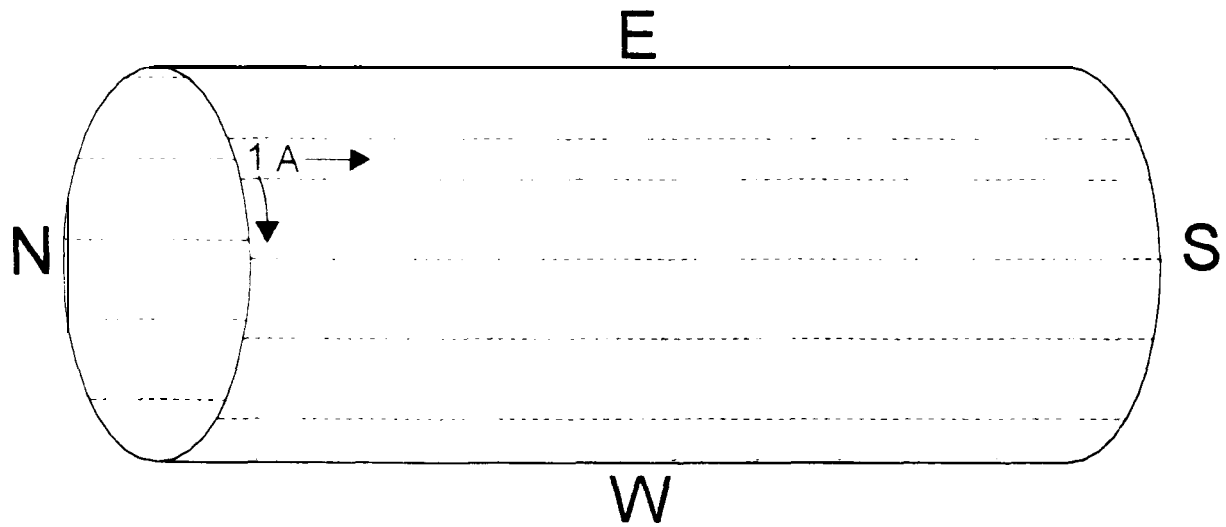
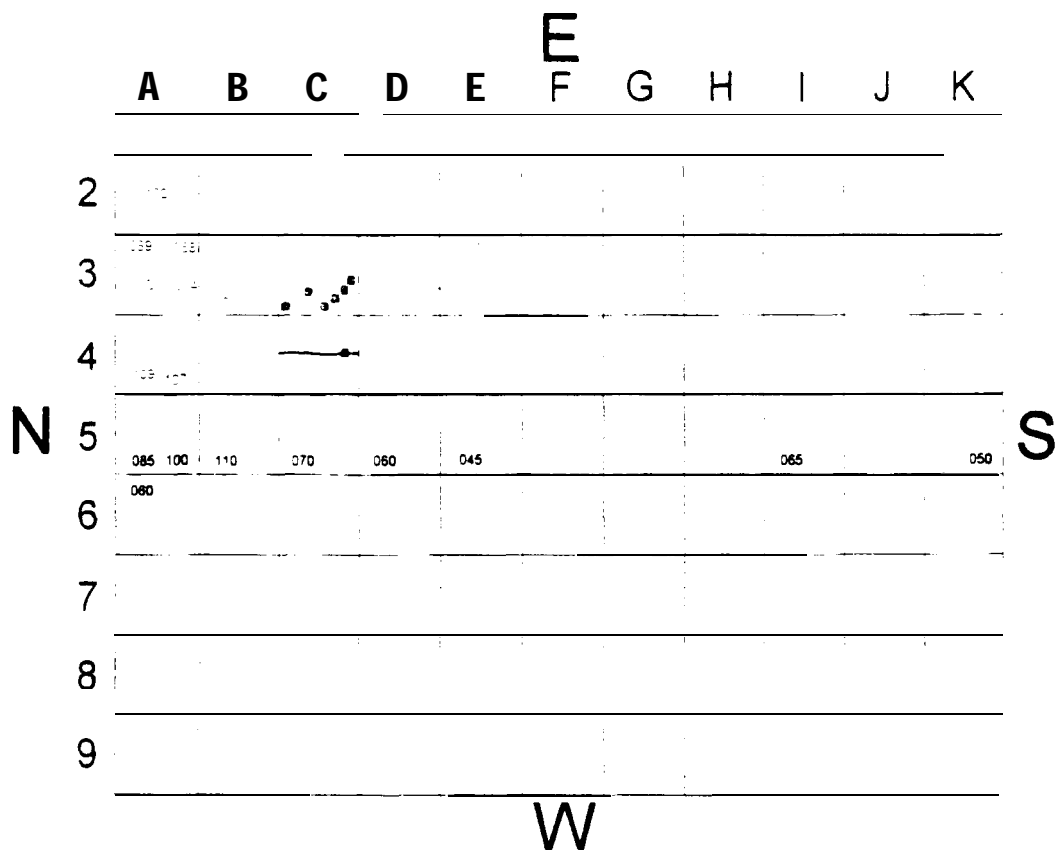
Tank #19

- Magnetic Flux Inspection
- Internal Corrosion Readings
- Weld
- Holes

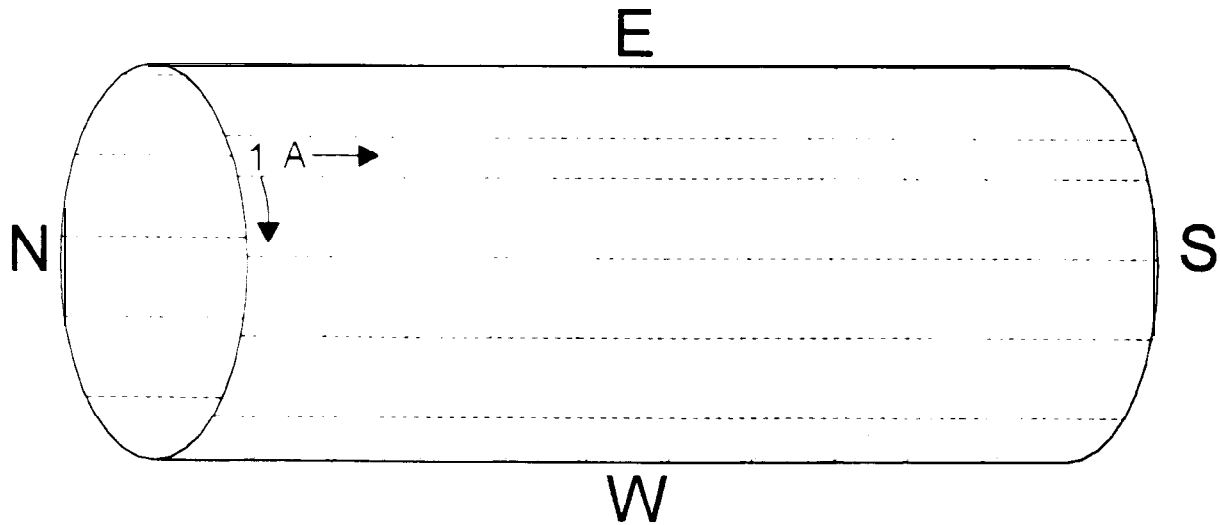
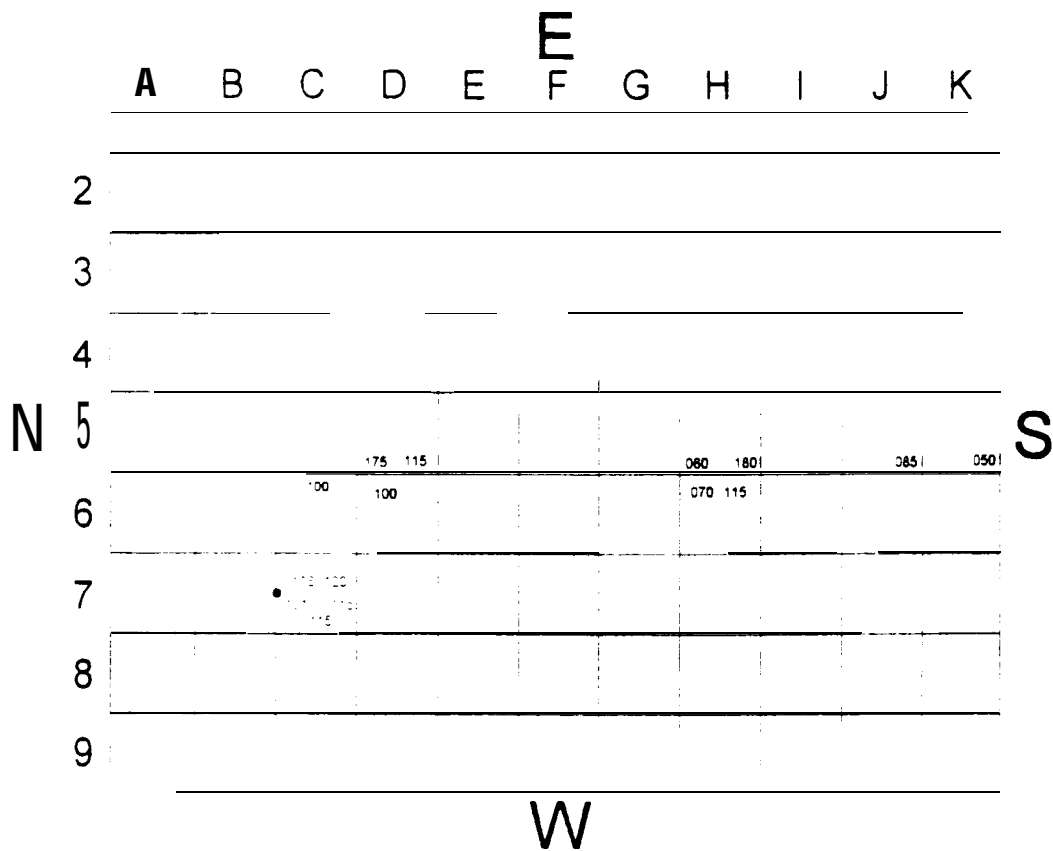
Tank #20

- ☐ Magnetic Flux Inspection
- ☐ Internal Corrosion Readings
- ☐ Holes

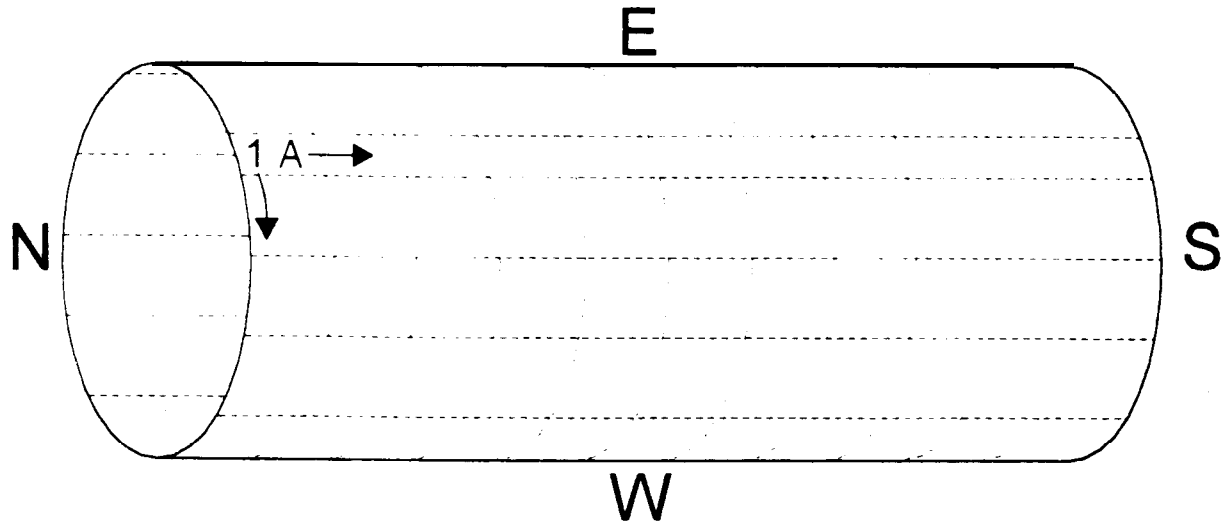
Tank #25

A	B	C	D	E	F	G	H	I	J	K	
1	214									132		
2	217		188	149	198			130	117	168		
3	120 214			157	133	130		111	113	103	143	
4	203			131								
N 5	140 201		110		151 075	110 080						S
6	214								172			
7	219											
8	219		143	186			170	151	162	127		
9	211									156

■ Magnetic Flux Inspection
